## Chapter Four

### The Macondo Well and the Blowout

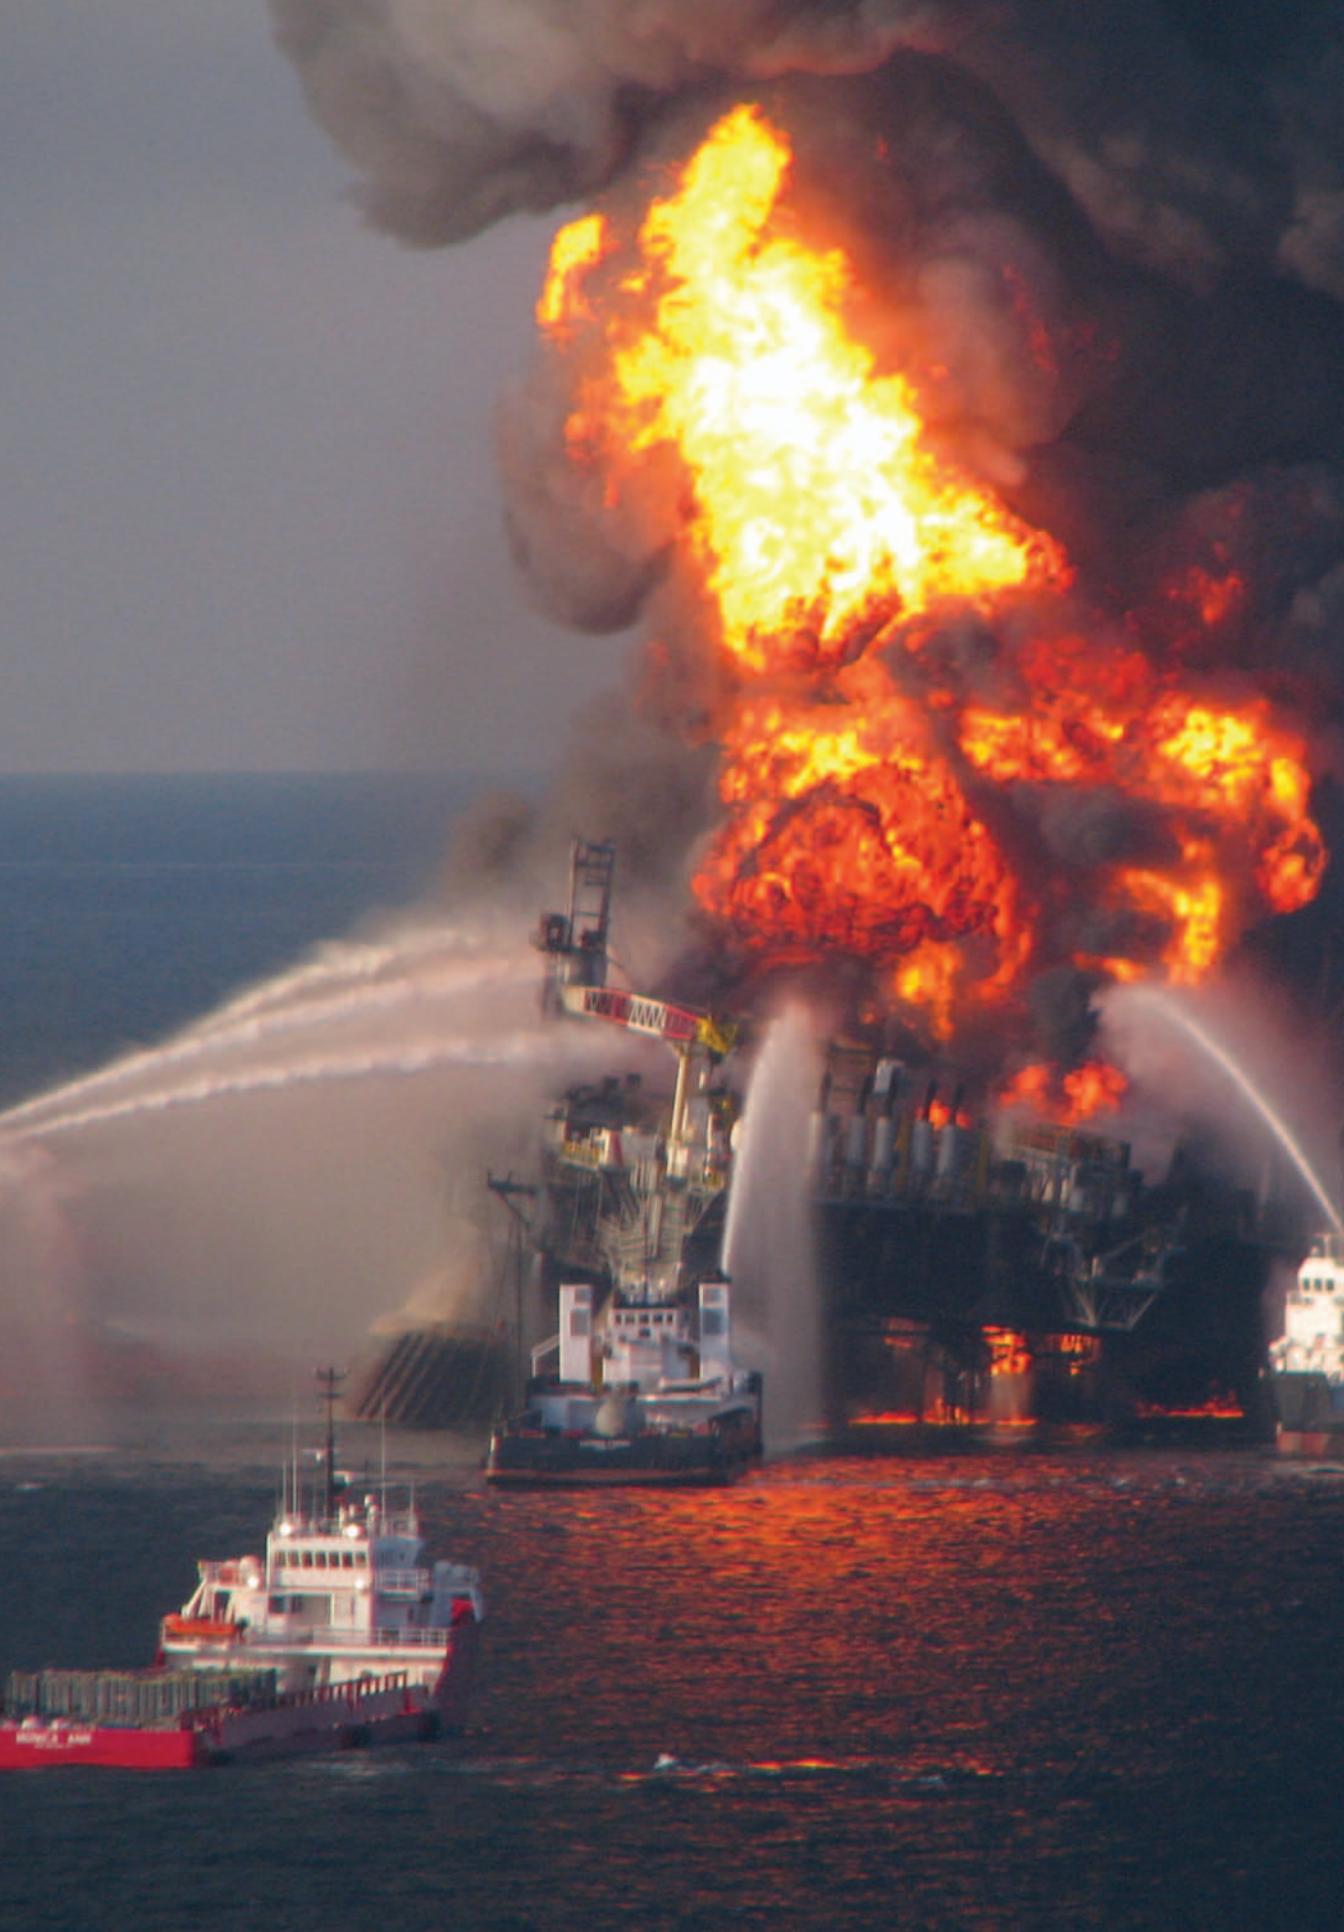
Fighting a losing battle, fireboats pour water onto the doomed rig in the hours after the Macondo well blowout. The tragic loss of the *Deepwater Horizon* at the close of the complex drilling project resulted from a series of missteps and oversights and an overall failure of management.

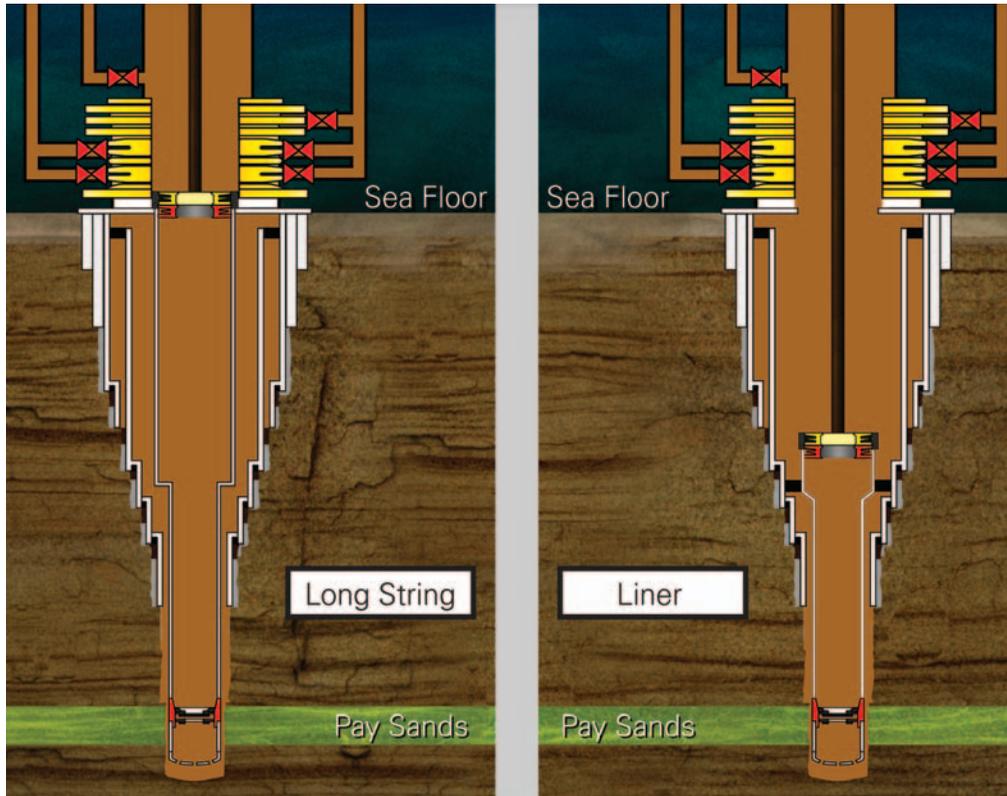
FIGURE 4.2: “Long String” vs. “Liner”

Two options for the Macondo production casing.

**Long string casing vs. liner.** BP's decision to employ a long string was not unprecedented. Long strings are used with some frequency by other operators in the Gulf of Mexico, although not very often at wells like Macondo—a deepwater well in an unfamiliar geology requiring a finesse cement job.<sup>126</sup> It is not clear whether the decision to use a long string well design contributed directly to the blowout:<sup>127</sup> But it did increase the difficulty of obtaining a reliable primary cement job in several respects,<sup>128</sup> and primary cement failure was a direct cause of the blowout. The long string decision should have led BP and Halliburton to be on heightened alert for any signs of primary cement failure.

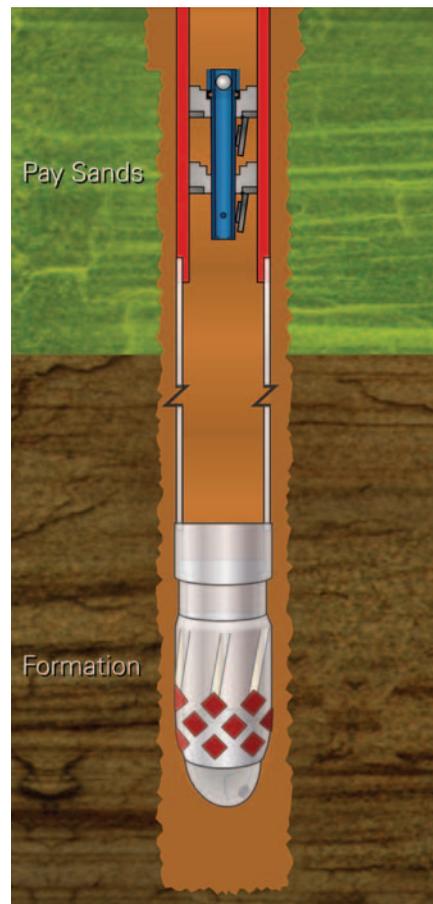
FIGURE 4.4: Shoe Track

The shoe track, showing the float collar assembly at the top and the reamer shoe at the bottom.

**Float-valve conversion and circulating pressure.** Whether the float valves converted, let alone whether "unconverted" float valves contributed to the eventual blowout, has not yet been, and may never be, established with certainty. But, what is certain is that BP's team again failed to take time to consider whether and to what extent the anomalous pressure readings may have indicated other problems or increased the risk of the upcoming cement job.

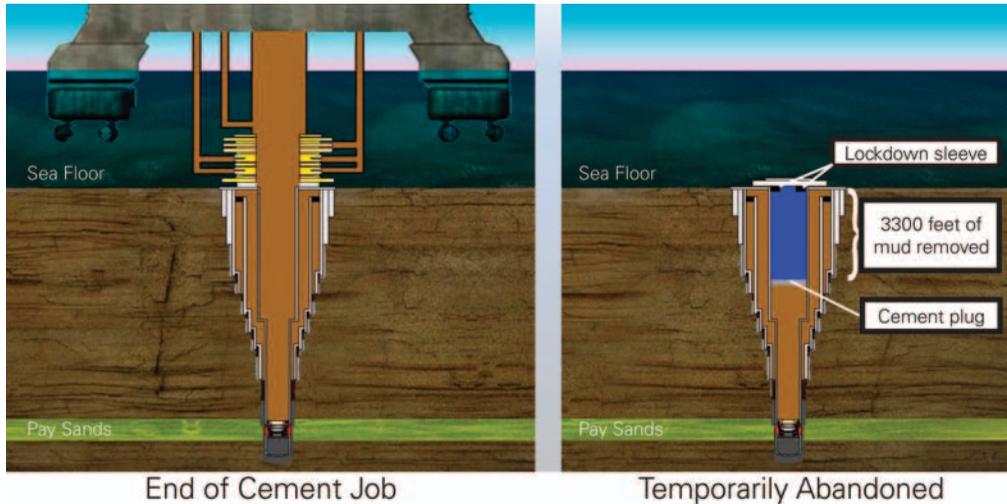
**FIGURE 4.5: Temporary Abandonment**

The status of the well before and after temporary abandonment.

*First, it was not necessary or advisable for BP to replace 3,300 feet of mud below the mud line with seawater. By replacing that much heavy drilling mud with much lighter*

*It was not necessary to set the cement plug 3,300 feet below the mudline.* The BP Macondo team chose to do so in order to set the lockdown sleeve last in the temporary abandonment sequence to minimize the chances of damage to the sleeve. Setting the lockdown sleeve would require 100,000 pounds of force. The BP Macondo team sought to generate that force by hanging 3,000 feet of drill pipe below the sleeve—hence the desire to set the cement plug 3,000 feet below the mud line. BP's desire to set the lockdown sleeve last did not justify the risks its decision created. BP could have used other proven means to protect the lockdown sleeve if set earlier in the process. It also did not need 3,000 feet of space to generate 100,000 pounds of force.<sup>147</sup> Merrick Kelley, the individual at BP in charge of lockdown sleeves in the Gulf of Mexico, told Commission staff that he had recommended setting the plug roughly 1,300 feet below the mud line (using heavier drill pipe), rather than 3,300 feet down. That would have significantly increased the margin of safety for the well.<sup>148</sup>

*BP's decision under these circumstances to displace mud from the riser before setting another barrier unnecessarily and substantially increased the risk of a blowout.* BP could have set the surface cement plug, or a mechanical plug, before displacing the riser.<sup>151</sup> BP could have replaced the mud in the wellbore with heavier mud sufficient to overbalance the well.<sup>152</sup> It is not apparent why BP chose not to do any of these things.

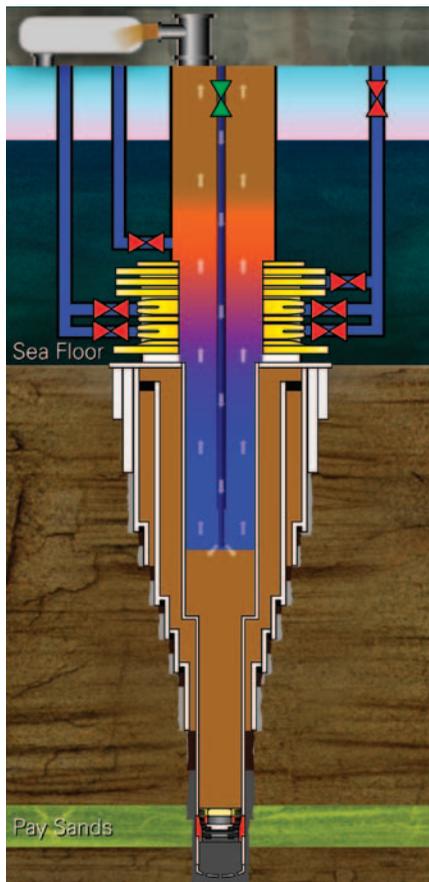
**FIGURE 4.6: Displacing Mud With Spacer and Seawater Before the Negative Pressure Test**

Seawater (blue) displaces mud (brown) from wellbore and riser, with spacer fluid separating the two.

While drilling crews routinely use water-based spacer fluids to separate oil-based drilling mud from seawater, the spacer BP chose to use during the negative pressure test was unusual. BP had directed M-I SWACO mud engineers on the rig to create a spacer out of two different lost-circulation materials left over on the rig—the heavy, viscous drilling fluids used to patch fractures in the formation when the crew experiences lost returns.<sup>71</sup> M-I SWACO had previously mixed two different unused batches, or “pills,” of lost-circulation materials in case there were further lost returns.<sup>72</sup> BP wanted to use these materials as spacer in order to avoid having to dispose of them onshore as hazardous waste pursuant to the Resource and Conservation Recovery Act, exploiting an exception that allows companies to dump water-based “drilling fluids” overboard if they have been circulated down through a well.<sup>73</sup> At BP’s direction, M-I SWACO combined the materials to create an unusually large volume of spacer that had never previously been used by anyone on the rig or by BP as a spacer, nor been thoroughly tested for that purpose.<sup>74</sup>

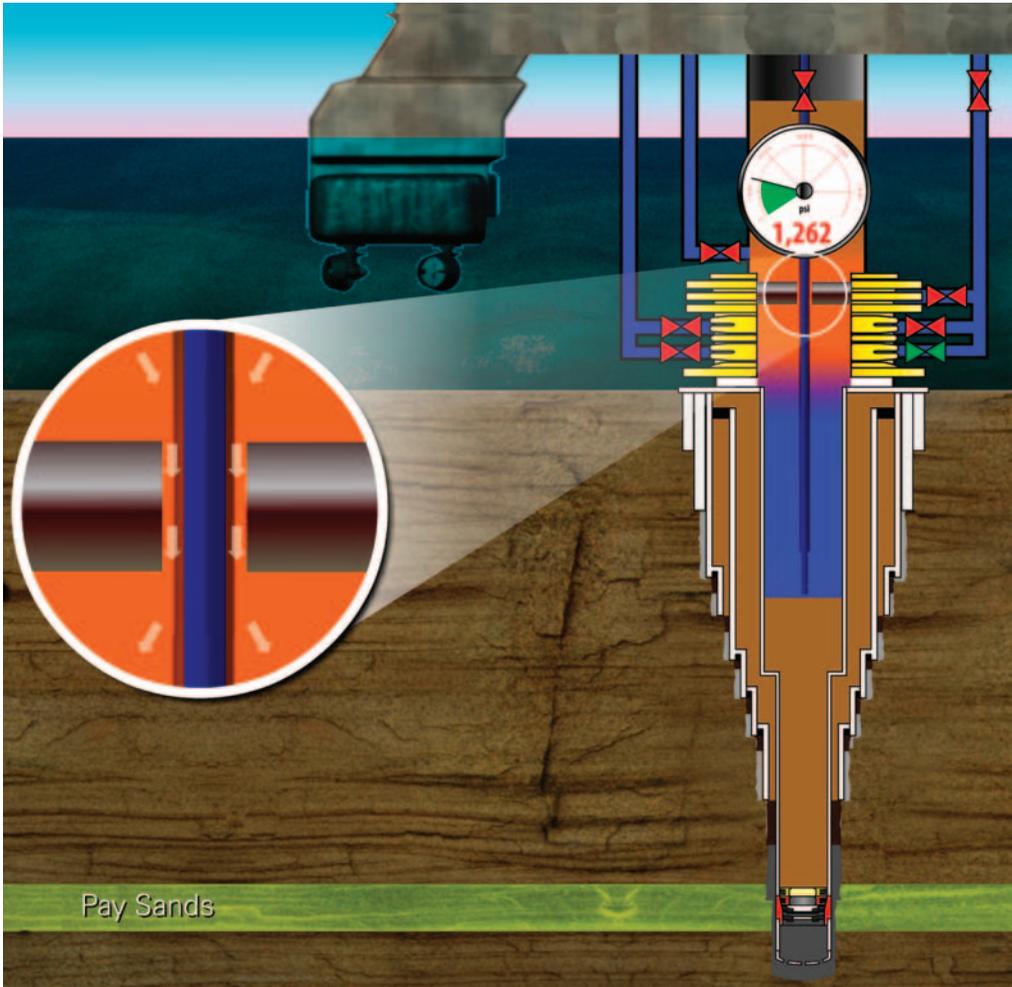
FIGURE 4.7: Fluids Leak Past Annular Preventer

The crew had noticed that the fluid level inside the riser was dropping, suggesting that spacer was leaking down past the annular preventer, out of the riser, and into the well (Figure 4.7). Harrell, who stayed behind in the drill shack as the tour continued, ordered the annular preventer closed more tightly to stop the leak.<sup>77</sup> Harrell then left the rig floor.

Spacer fluids (orange) leak past annular preventer.

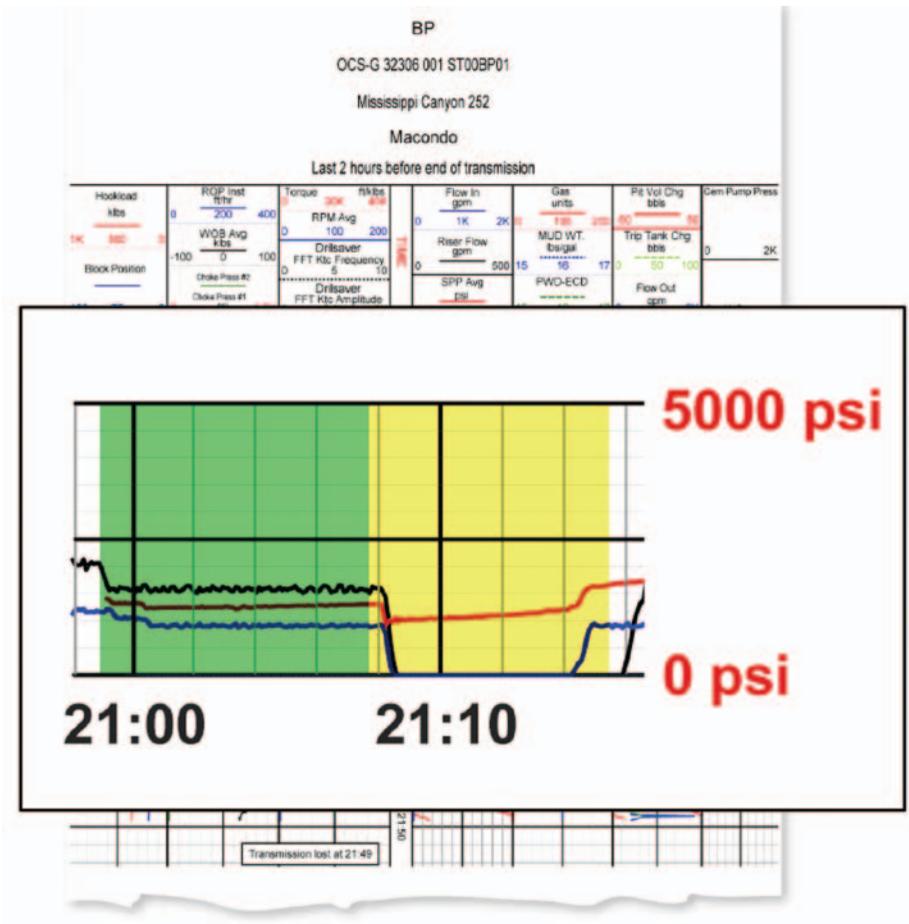
FIGURE 4.8: Increasing Drill-Pipe Pressure

Sperry Sun drill-pipe pressure data (in red).

magnitude of the increase may have appeared only as a subtle trend on the Sperry Sun display, the change in direction from decreasing to increasing was not.<sup>91</sup>

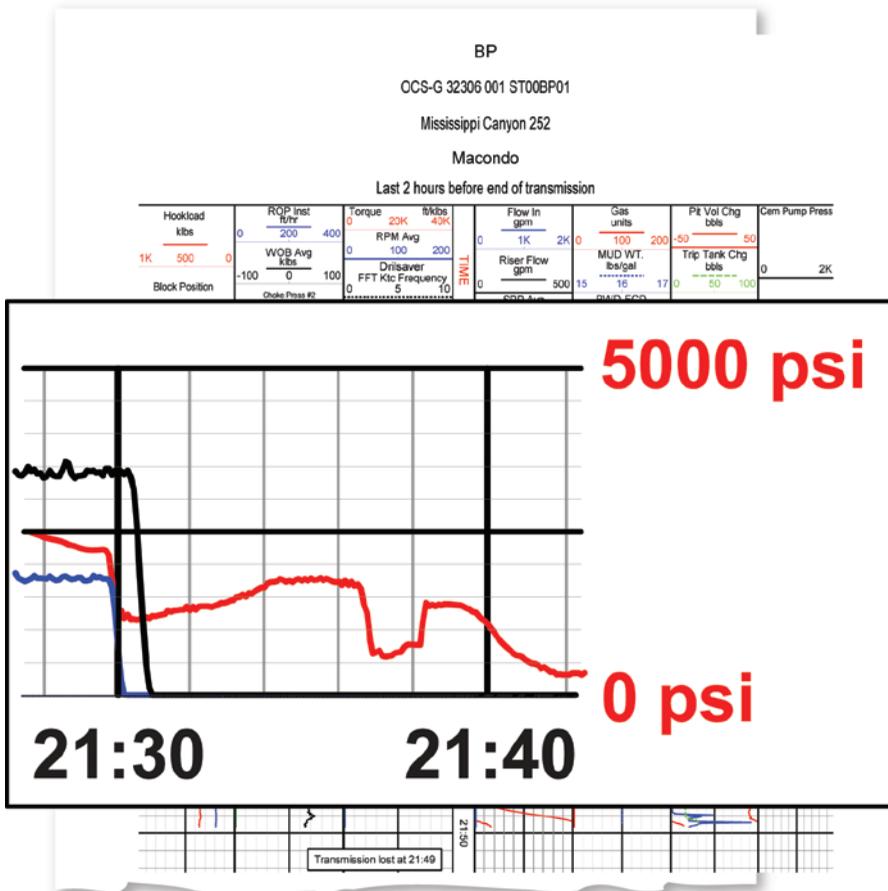
FIGURE 4.9: Fluctuating Drill-Pipe Pressure

Sperry Sun drill-pipe pressure data (in red).

floorhand Caleb Holloway to bleed off the drill-pipe pressure, in an apparent attempt to eliminate the difference.<sup>112</sup> The drill-pipe pressure initially dropped off as expected, but immediately began climbing again.<sup>113</sup> Young and Anderson left the rig floor.<sup>114</sup> Despite the mounting evidence of a kick, however, neither Revette nor Anderson performed a visual flow check or shut in the well.
