## Chapter Four

### The Macondo Well and the Blowout

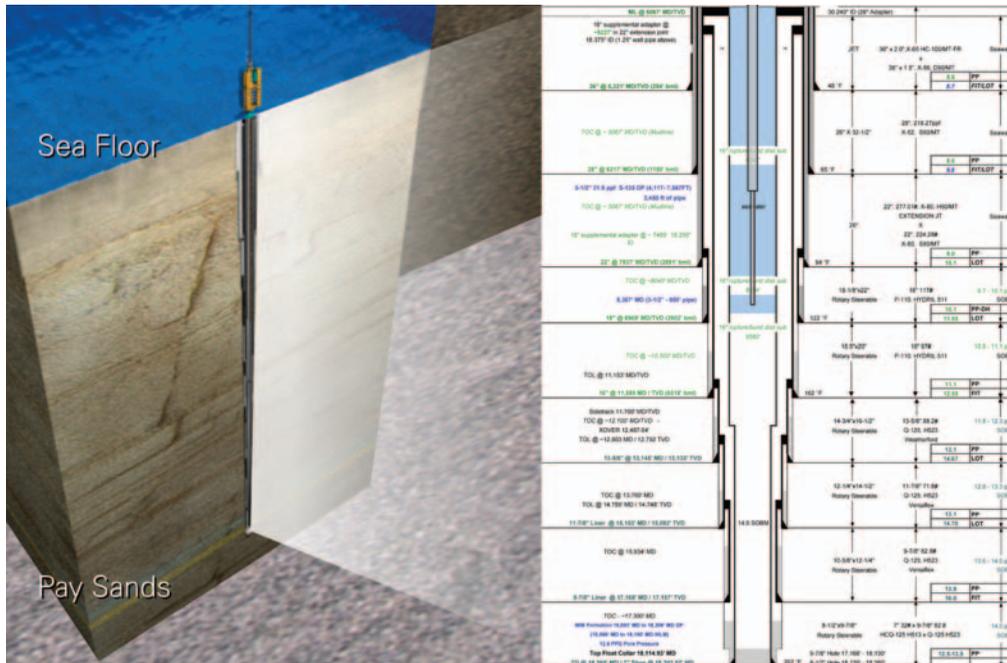
FIGURE 4.1: Macondo Well Schematic

Below the wellhead stretched four telescopic casing strings installed by the *Marianas* to reinforce the hole it had begun drilling. The *Deepwater Horizon* crew proceeded to drill deeper into the Earth, setting progressively smaller-diameter casing strings along the way as required. (Figure 4.1) They cemented each new string into place, anchoring the well to—and sealing the well off from—the surrounding rock.
